U.S. Army Corps of Engineers – Charleston District - Regulatory Division
JURISDICTIONAL DETERMINATION REQUEST

Project Name & Location Address: Steeplechase IP Site: 399 Black River Road, near Camden, South Carolina

Reference: Request for Jurisdictional Determination

Steeplechase IP Site – 277.91 acres
SAC 2001-34608-5JK
Camden, Kershaw County, South Carolina
S&ME Project No. 4261-14-036

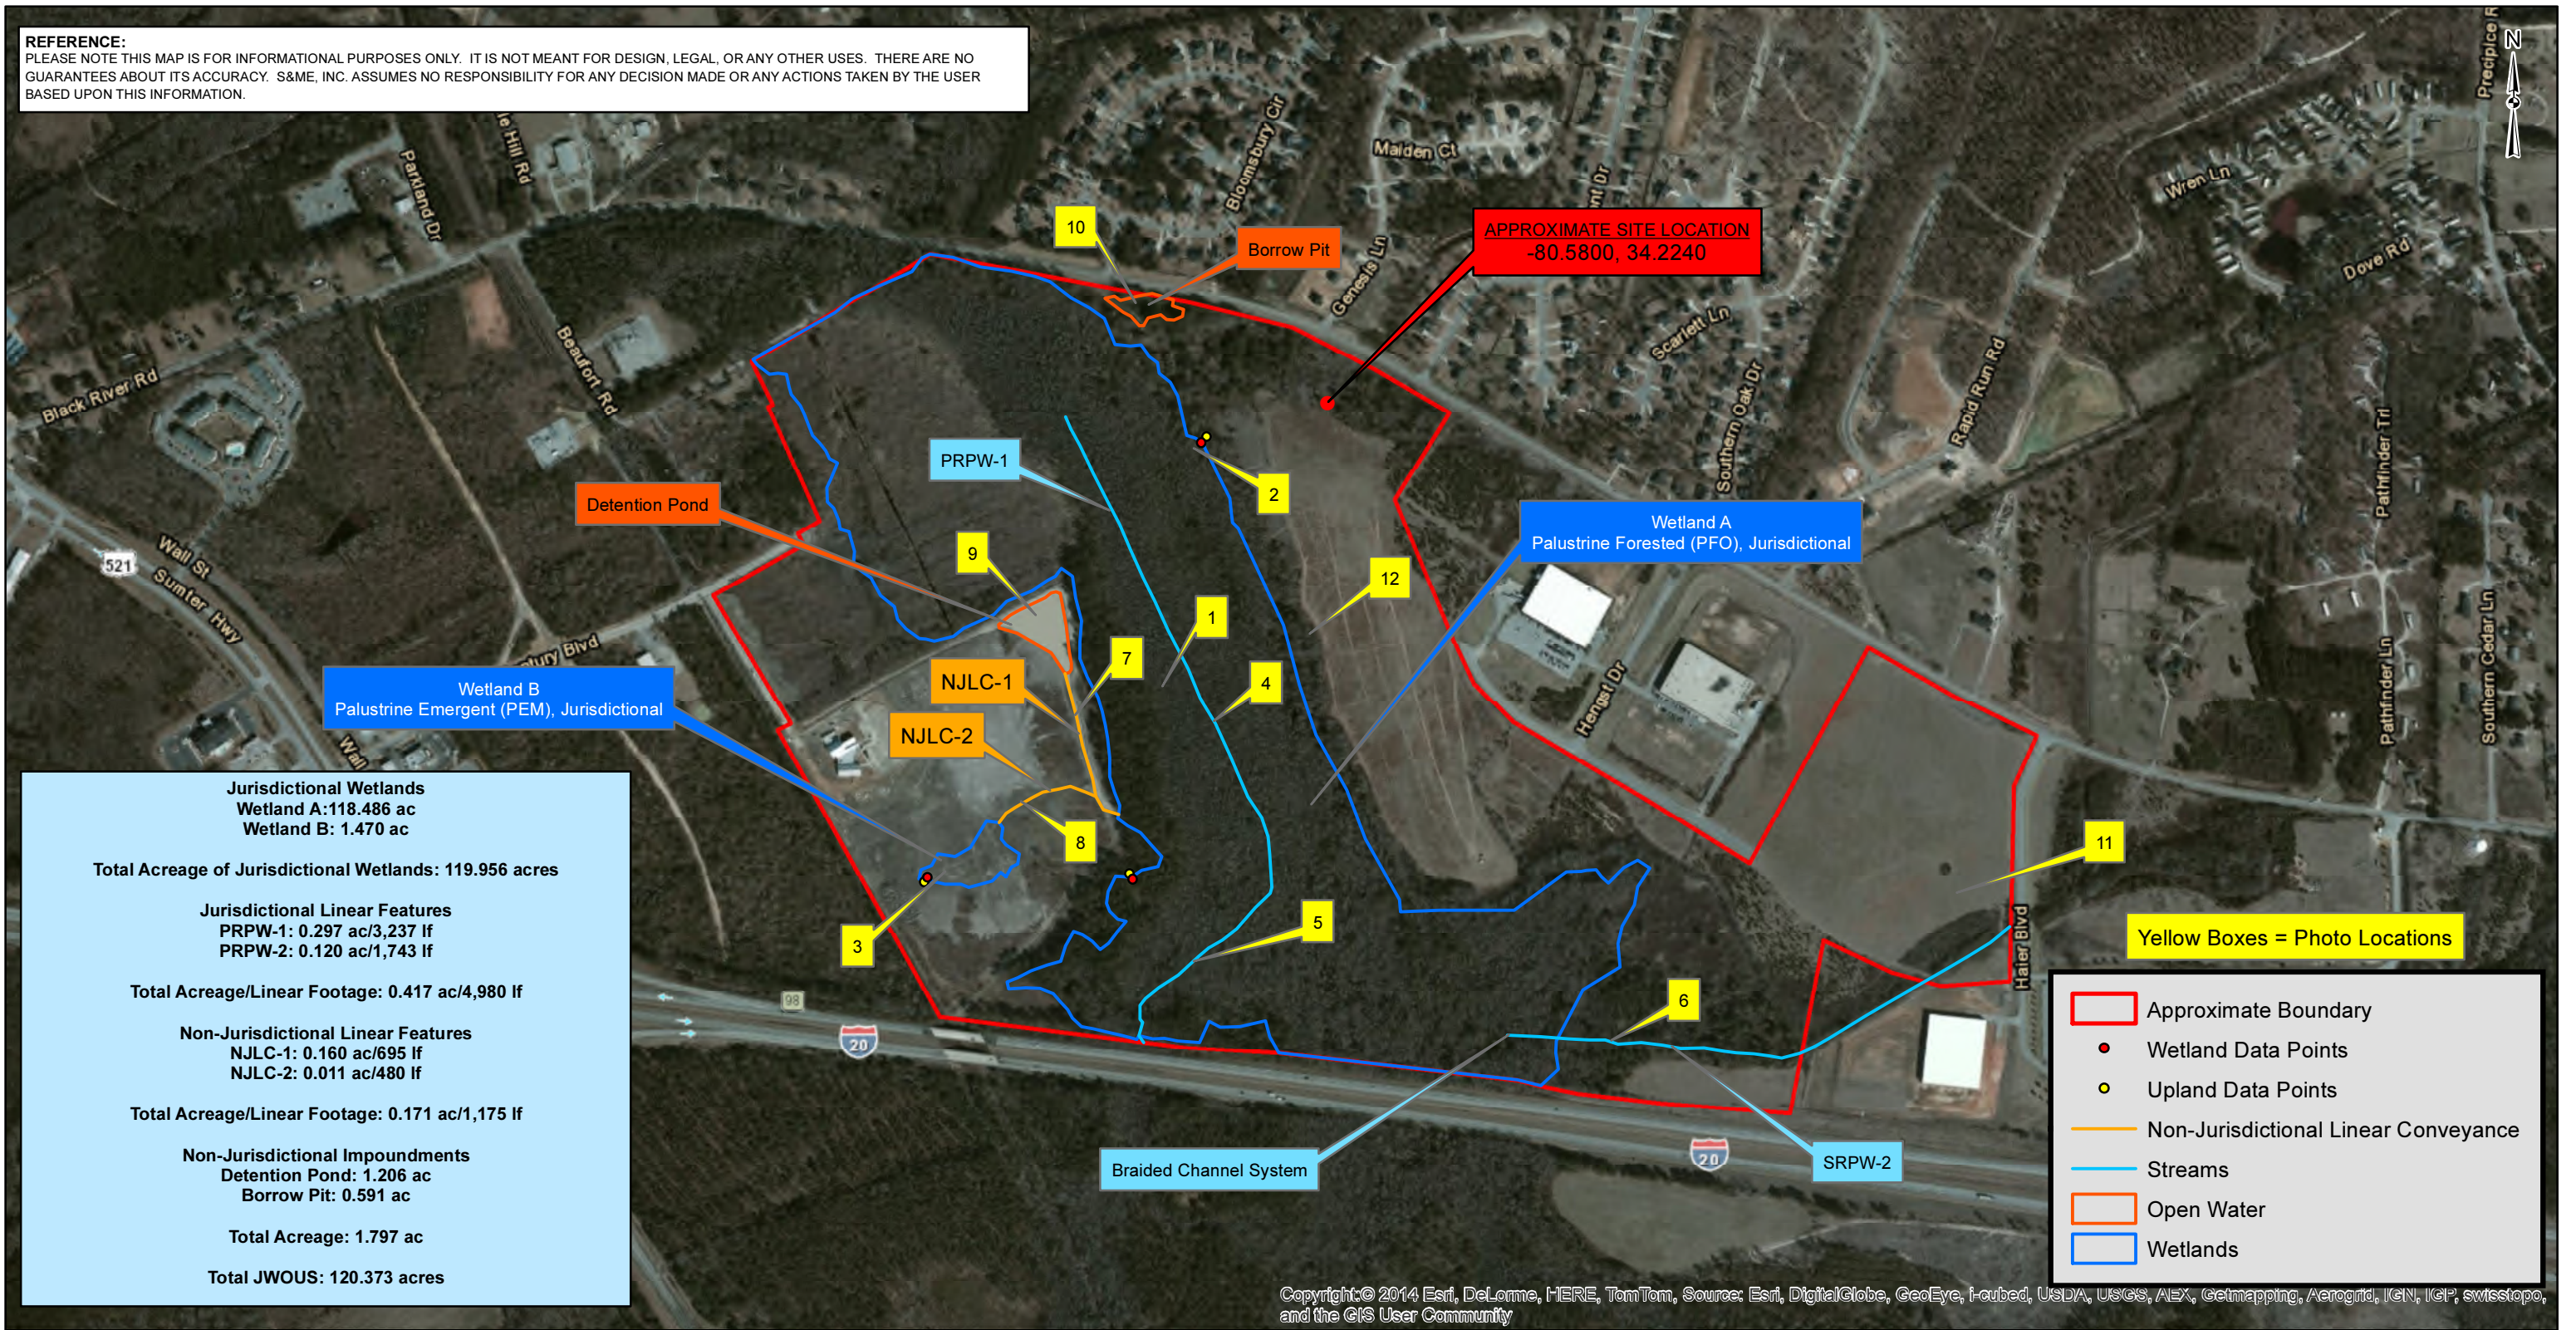
FIGURE NO.
3

Jurisdictional Wetlands
Wetland A: 118.486 ac
Wetland B: 1.470 ac

Total Acreage of Jurisdictional Wetlands: 119.956 acres

Jurisdictional Linear Features
PRPW-1: 0.297 ac/3,237 lf
PRPW-2: 0.120 ac/1,743 lf

Total Acreage/Linear Footage: 0.417 ac/4,980 lf

Non-Jurisdictional Linear Features
NJLC-1: 0.160 ac/695 lf
NJLC-2: 0.011 ac/480 lf

Total Acreage/Linear Footage: 0.171 ac/1,175 lf

Non-Jurisdictional Impoundments
Detention Pond: 1.206 ac
Borrow Pit: 0.591 ac

Total Acreage: 1.797 ac

Total JWOUS: 120.373 acres

Please refer to Figure 3 (Aerial Map) in Appendix A for the approximate locations of these features.

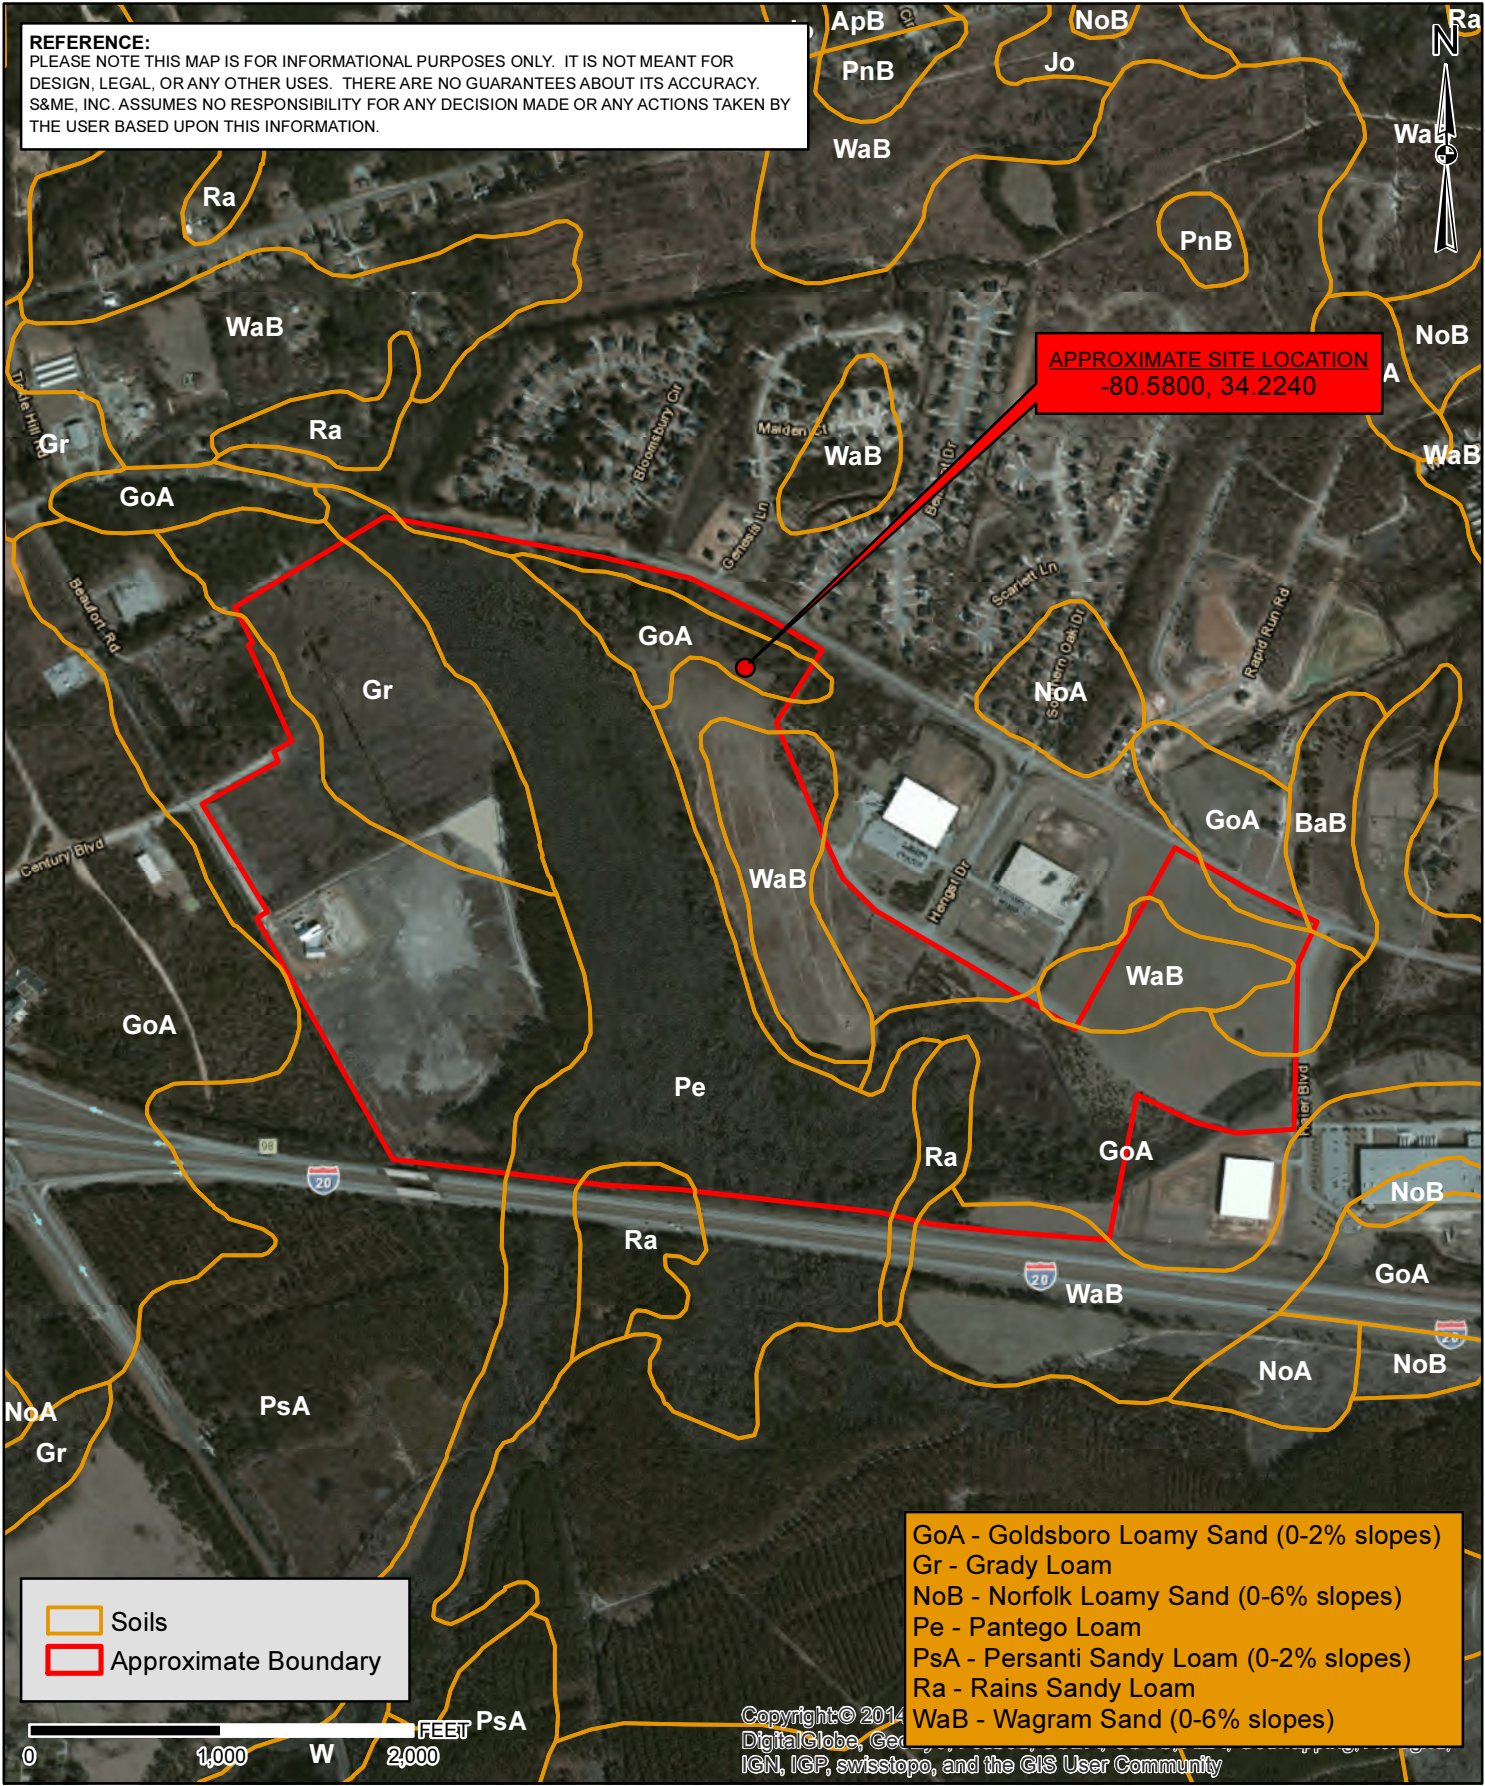
FIGURE NO.
4

GoA - Goldsboro Loamy Sand (0-2% slopes)
 Gr - Grady Loam
 NoB - Norfolk Loamy Sand (0-6% slopes)
 Pe - Pantego Loam
 PsA - Persanti Sandy Loam (0-2% slopes)
 Ra - Rains Sandy Loam
 WaB - Wagram Sand (0-6% slopes)

Upland areas (Photographs 11-12) on the site consist of pine-mixed hardwoods, mixed-hardwoods, planted pine, cutover forestland, and open fields. These portions of the site consist primarily of non-hydric soil series such as Goldsboro, Norfolk, Persanti, and Wagram listed in the *Soil Survey of Kershaw County* and the U.S. Department of Agriculture - Natural Resources Conservation Service (USDA-NRCS) Web Soil Survey (Figure 4 – Soils Map). Wetland vegetation, hydric soils, or hydrology were not observed in the upland areas.

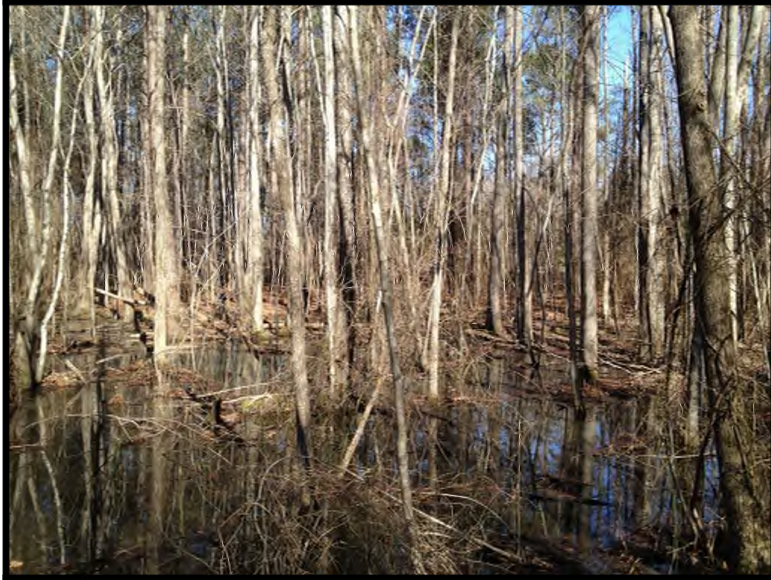
1 Forested wetland (Wetland A) located on the central portion of the site.

| ID | Photo ID | Wetland Type | Approximate Acreage |
|---|---|---|---|
| Wetland A | 1-2 | Palustrine forested (PFO)/scrub-shrub (PSS) wetland located on the central portion of the site. | 118.486 ac |

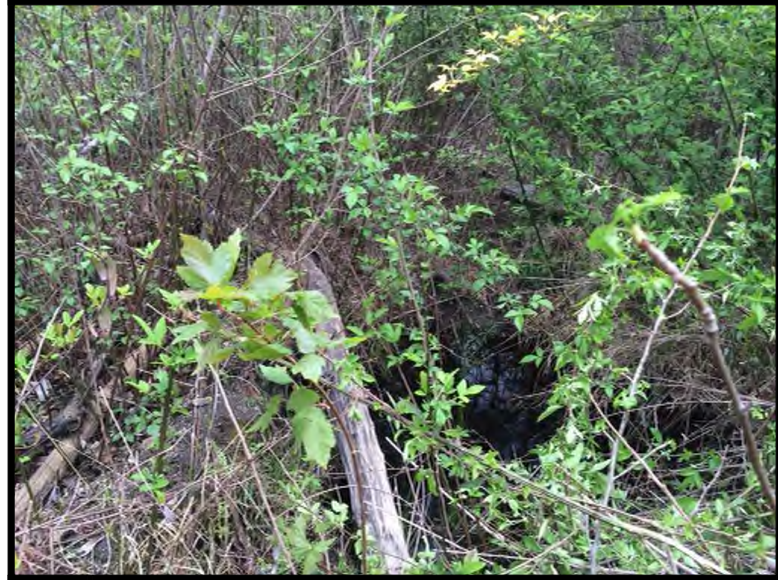
2 Shrub-scrub wetland (Wetland A) located on the northern portion of the site.

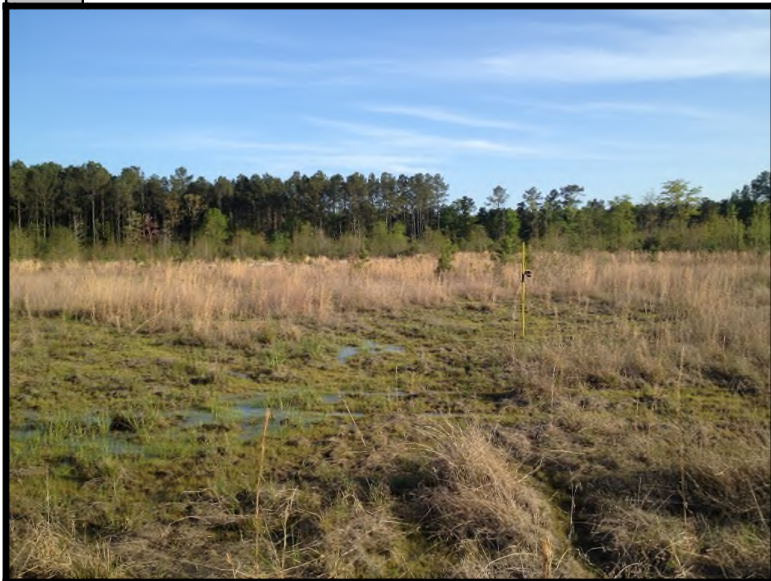
3 Palustrine emergent wetland (Wetland B) located on the southwest portion of the site.

| ID | Photo ID | Wetland Type | Approximate Acreage |
|---|---|---|---|
| Wetland B | 3 | Palustrine emergent (PEM) wetland located on the southwestern portion of the site. | 1.470 ac |

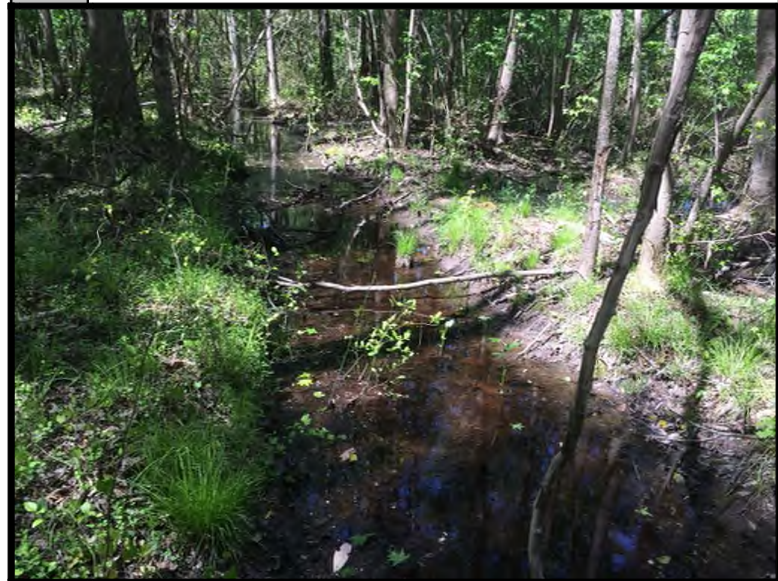
4 Perennial stream (PRPW-1) flowing through Wetland A on the central portion of the site.

| ID | Photo ID | Comments | Approximate Acreage/Linear Footage |
|---|---|---|---|
| PRPW-1 | 4-5 | Perennial, jurisdictional tributary flowing through Wetland A on the central portion of the site. | 0.297 ac/3,237 lf |

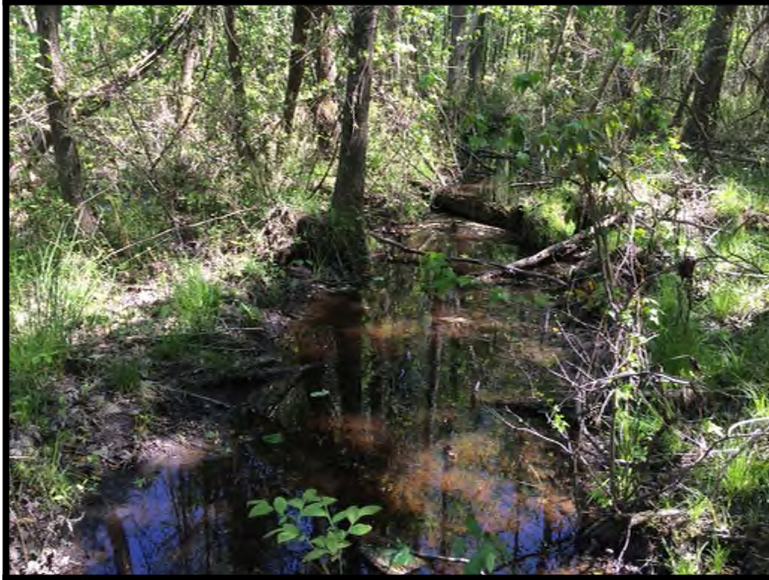
5 Perennial stream (PRPW-1) flowing through Wetland A on the southern portion of the site.

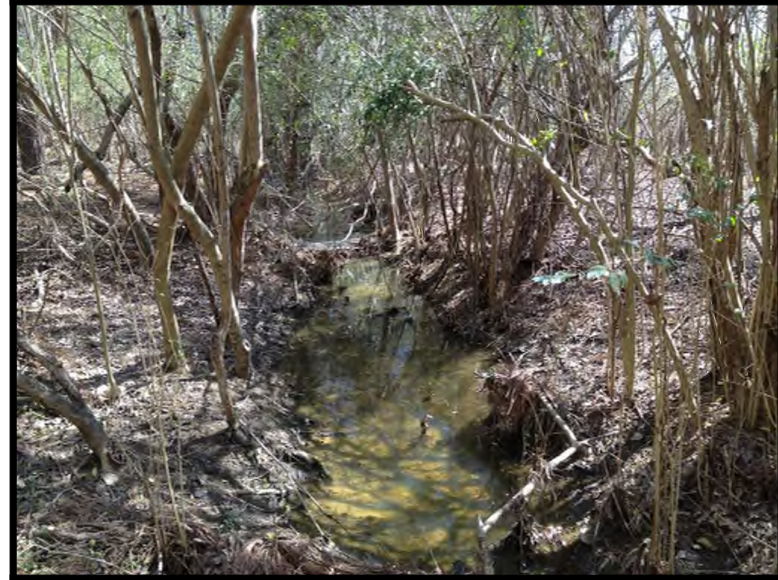
6 Seasonal stream (SRPW-2) flowing on the southeastern portion of the site.

| ID | Photo ID | Comments | Approximate Acreage/Linear Footage |
|---|---|---|---|
| SRPW-2 | 6 | Seasonal, jurisdictional tributary flowing on the southeastern portion of the site. Flows into Wetland A where it becomes a braided channel system. | 0.120 ac/1,743 lf |

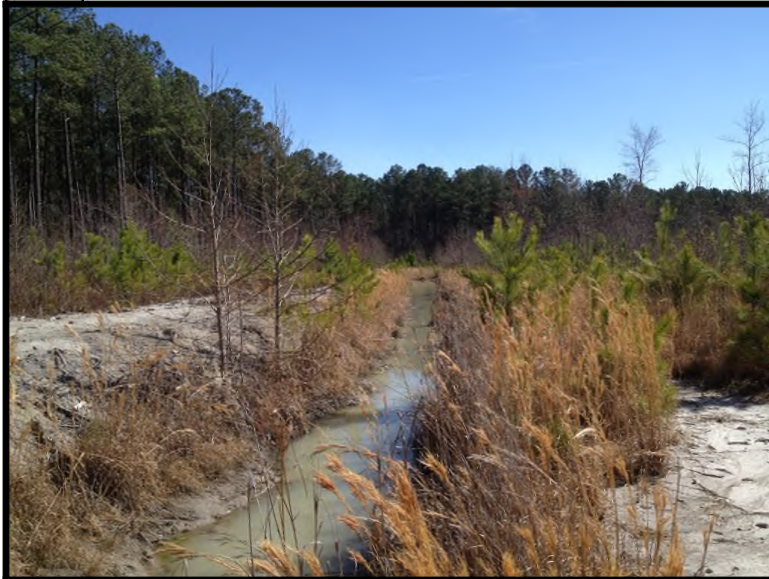
7 Non-jurisdictional linear conveyance (NJLC-1) located on the western portion of the site.

| ID | Photo ID | Comments | Approximate Acreage/Linear Footage |
|---|---|---|---|
| NJLC-1 | 7 | NJLC located on the western portion of the site. | 0.160 ac/695 lf |

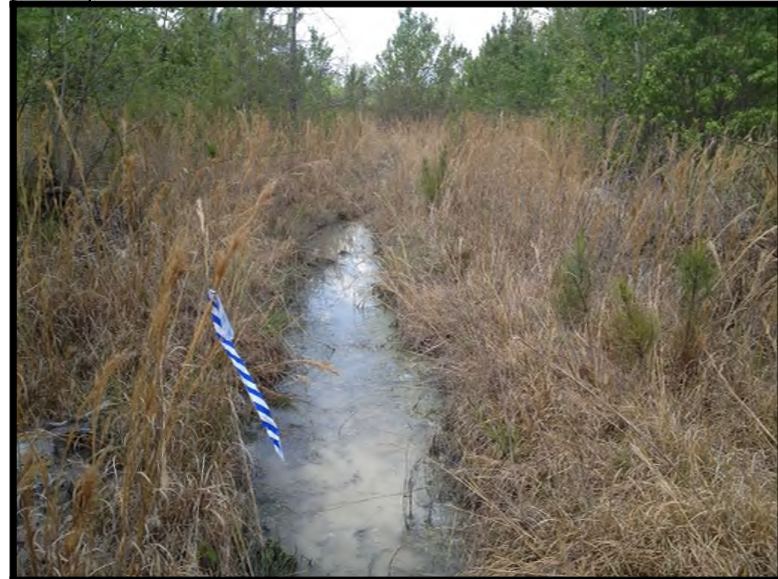
8 Non-jurisdictional linear conveyance (NJLC-2) located on the southwestern portion of the site.

| ID | Photo ID | Comments | Approximate Acreage/Linear Footage |
|---|---|---|---|
| NJLC-2 | 8 | NJLC located on the southwestern portion of the site. | 0.011 ac/480 lf |

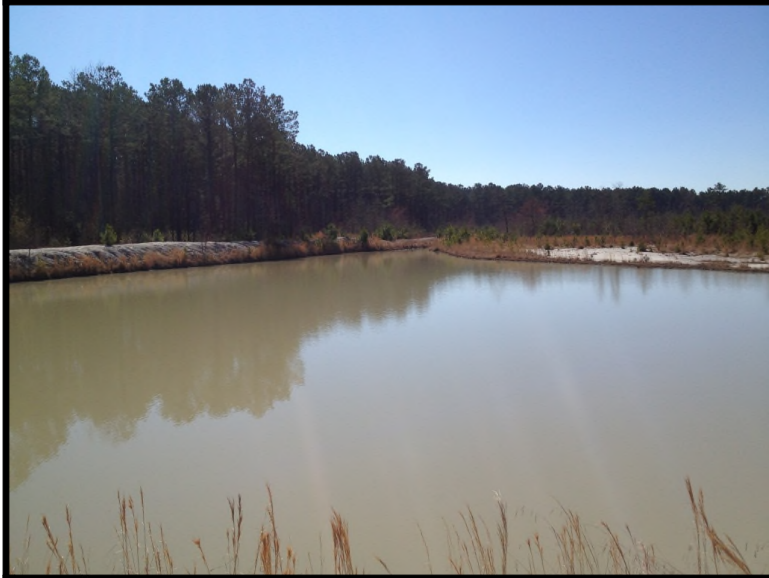
9 Upland-dug detention pond located on the western portion of the site.

| ID | Photo ID | Comments | Approximate Acreage |
|---|---|---|---|
| Detention Pond | 9 | Upland-dug detention pond located on the western portion of the site. | 1.206 ac |

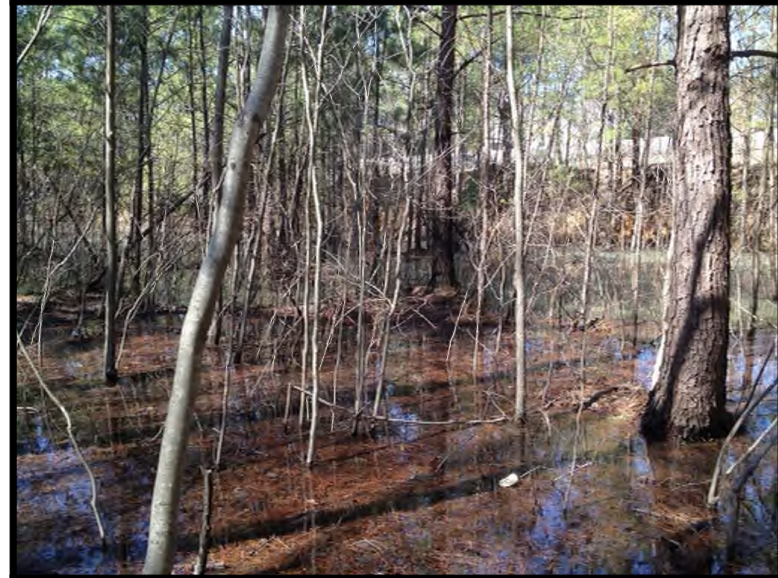
10 Upland-dug borrow pit located on the northern portion of the site.

| ID | Photo ID | Comments | Approximate Acreage |
|---|---|---|---|
| Borrow Pit | 10 | Upland-dug borrow pit located on the northern portion of the site. | 0.591 ac |

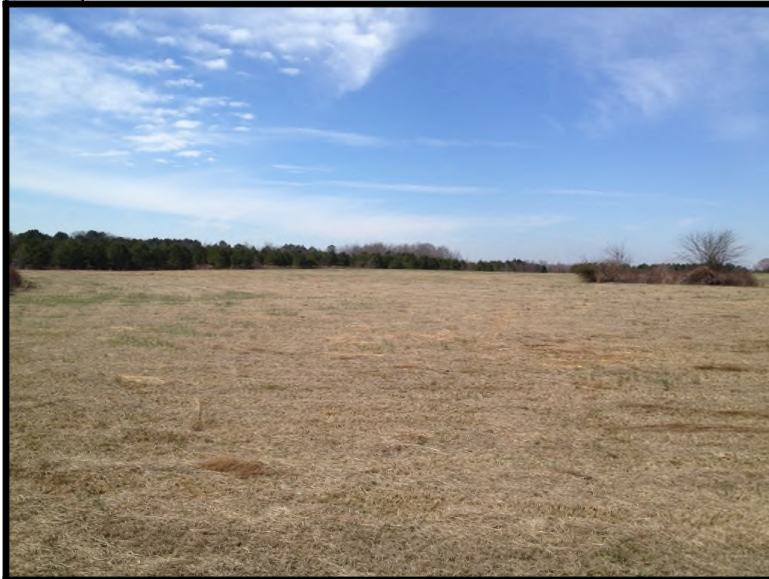
11 Open field/fallow agricultural land located on the eastern portion of the site.

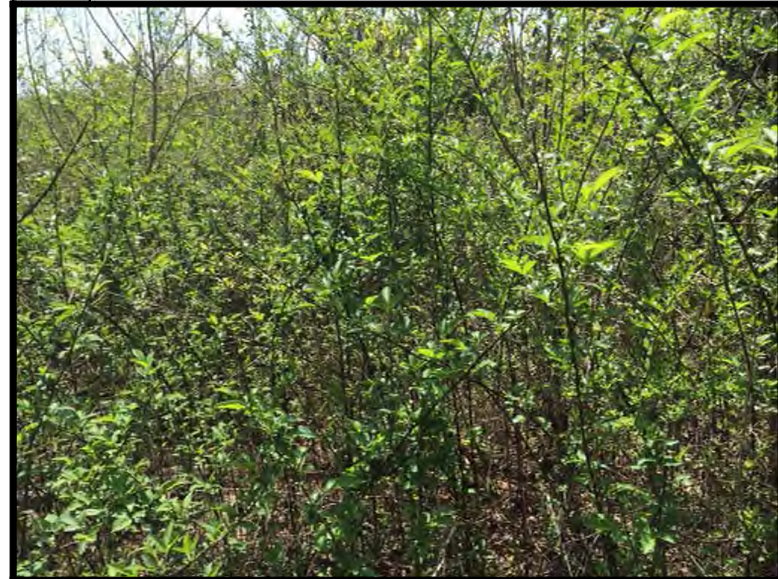
12 Cutover forestland located on the central portion of the site.
