JURISDICTIONAL DETERMINATION REQUEST

Reference: Request for Jurisdictional Determination

Governor's Hill Site – 210.46 acres
SAC 81-2003-0319(K)
Camden, Kershaw County, South Carolina
S&ME Project No. 4261-14-035

On behalf of Kershaw County Economic Development Office, S&ME, Inc. (S&ME) has completed a Wetland Delineation at the above-referenced site. The approximately 210.46-acre site is located at 674 Mt. Olivet Road near Camden, Kershaw County, South Carolina. The site consists of a portion of one Kershaw County tax parcel number (301-00-00-002), owned by Kershaw County. The site consists primarily of forestland. The site is located in the Wateree River Watershed (HUC 03050104-03) within the Catawba River Basin and USACE Watershed Group 5. Please refer to Figures 1-5 in Appendix A for depictions of the site and surrounding features.

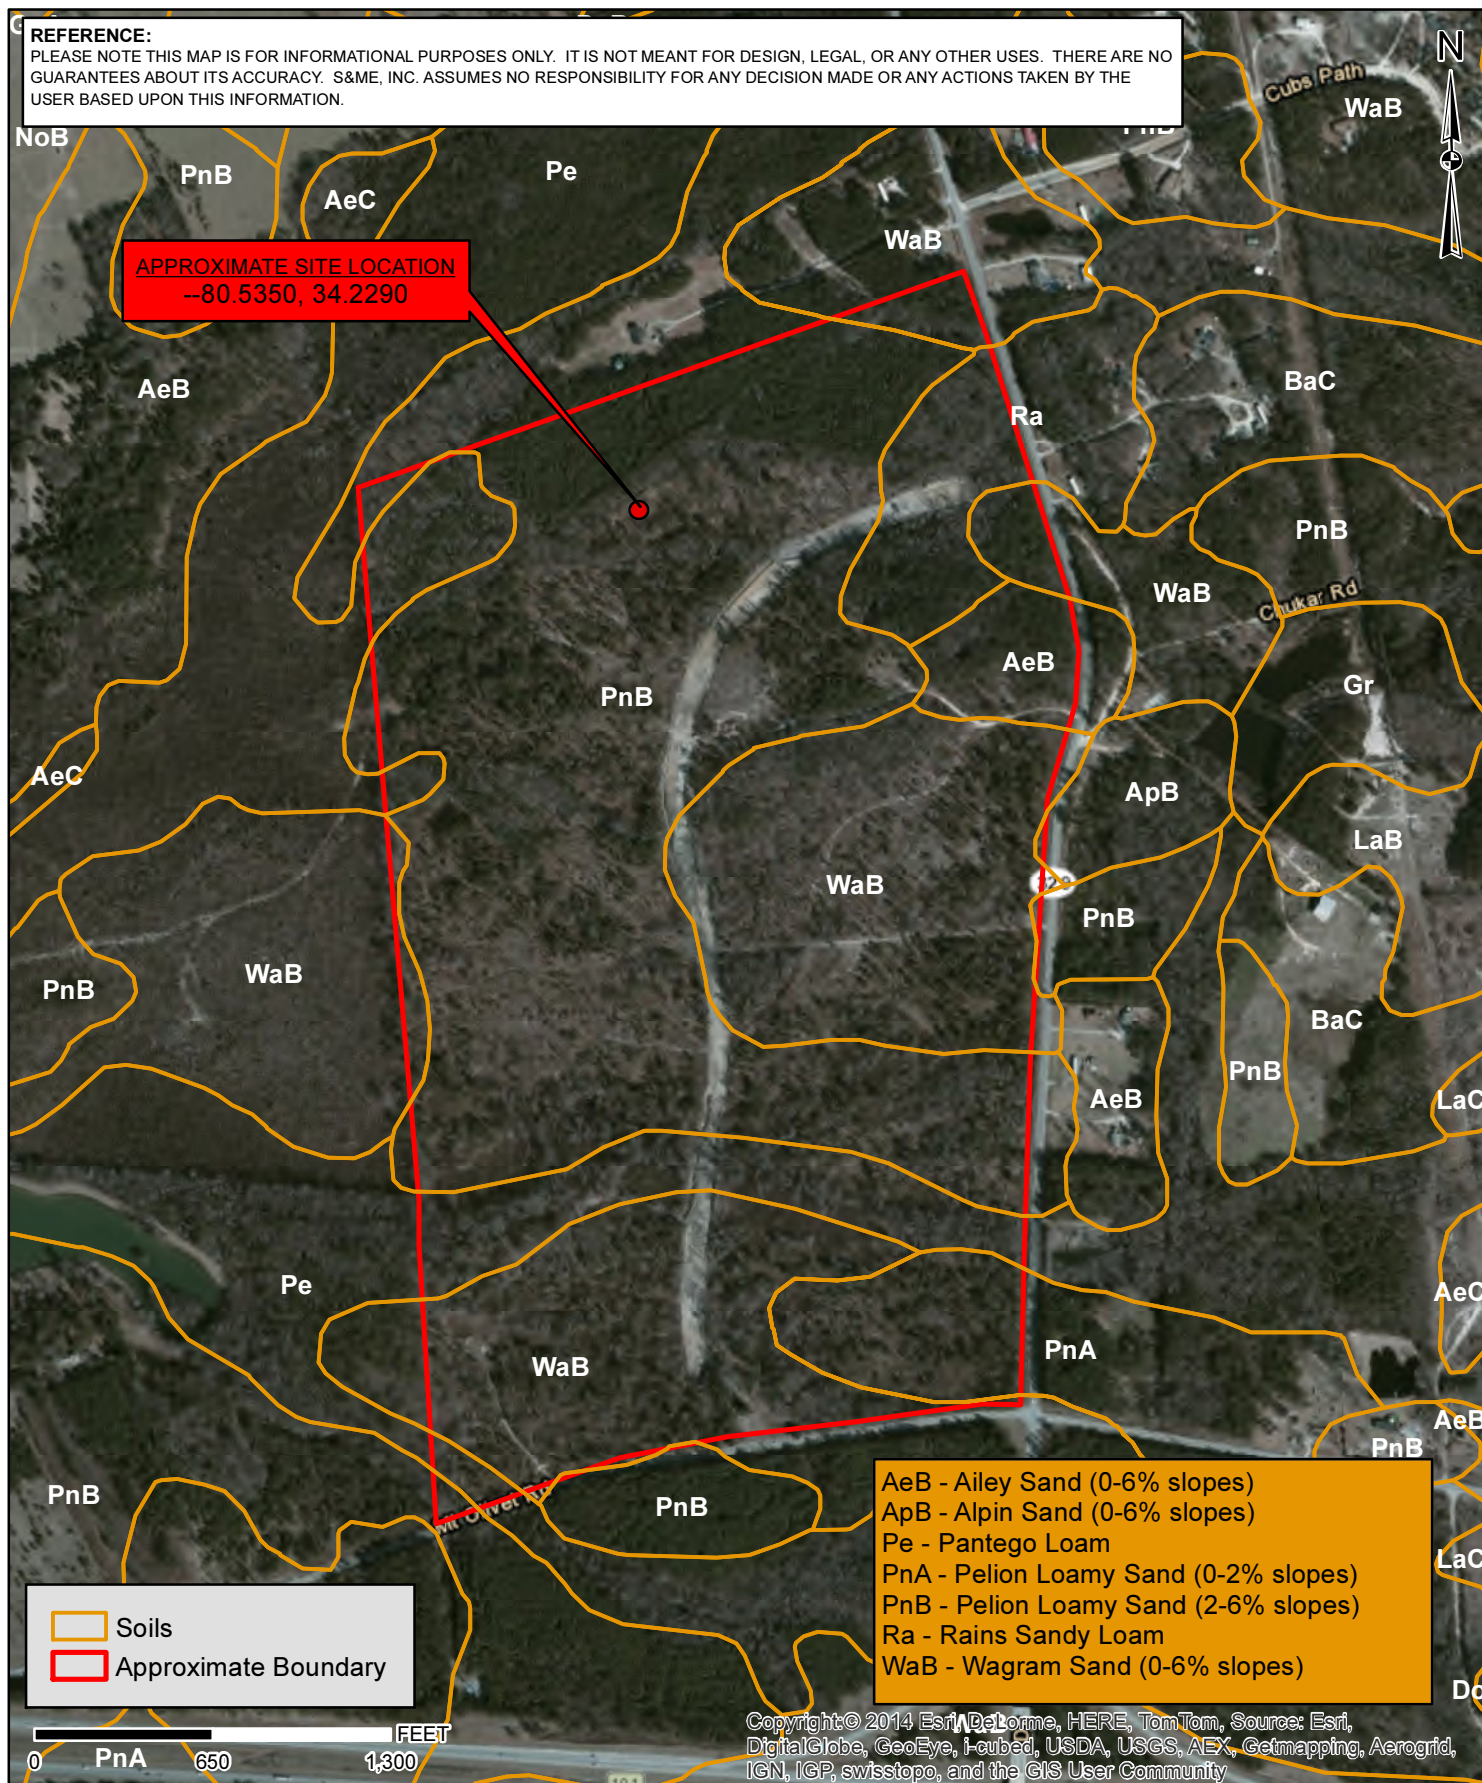
Upland areas (Photographs 14-16) on the site consist of pine-mixed hardwoods, mixed-hardwoods, and planted pine. These portions of the site consist primarily of non-hydric soil series such as Ailey, Alpin, Pelion, and Wagram listed in the *Soil Survey of Kershaw County* and the U.S. Department of Agriculture - Natural Resources Conservation Service (USDA-NRCS) Web Soil Survey (Figure 4 – Soils Map). Wetland vegetation, hydric soils, or hydrology were not observed in the upland areas.

Site Soils Map
